Manhole Inspection Summary

Manhole # S51O__057MH

Location Address: **light house point entrance**

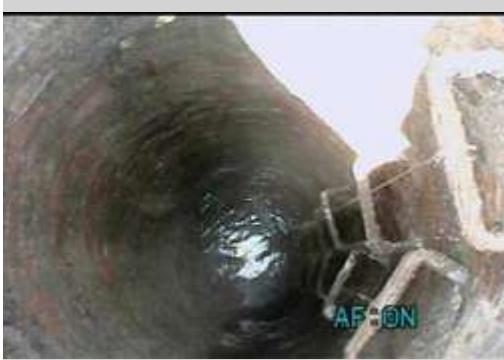
Defect 2

Count: **13** Missing: **0** ☒ **Corroded**

Corroded steps

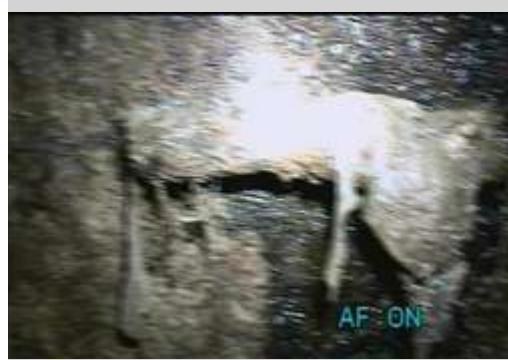
Defect 1

Infiltration: ☐ None ☐ Joint ☐ Cracks ☐ Mortar ☐ Roots ☒ **Wall**

☒ **Evidence Of Surcharge** Depth: **6** (ft.) ☐ Active Surcharge Present

surcharge evidence and barrel infiltration

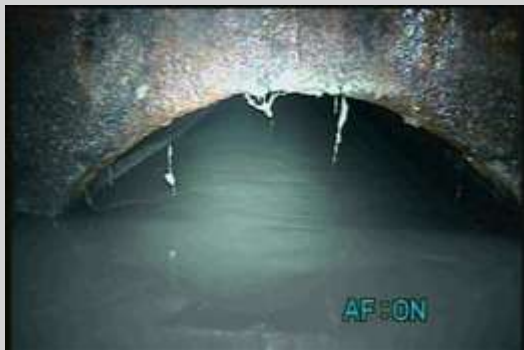
12 O'Clock Outflow

36 in. Circular Gravity Sewer
Pipe Out @ 12 O'Clock

Invert Depth: **18.80** (ft.) Flow Characteristics: **Fast**

Infiltration: **None**

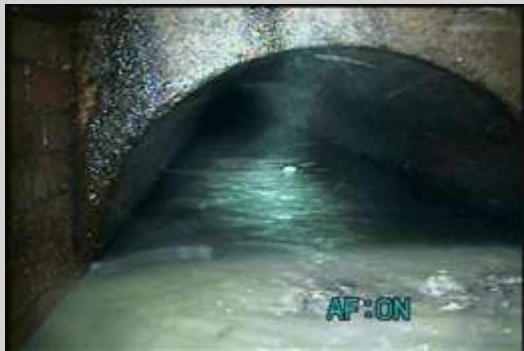
6 O'Clock Inflow

36 in. Circular Gravity Sewer
Pipe In @ 6 O'Clock

Invert Depth: **18.30** (ft.) Flow Characteristics: **Fast**

Infiltration: **None**

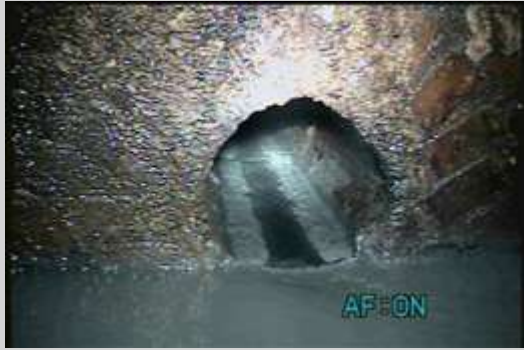
9 O'Clock Inflow

10 in. Circular Gravity Sewer
Pipe In @ 9 O'Clock

Invert Depth: **18.30** (ft.) Flow Characteristics: **Fast**

Infiltration: **None**
